# 船用柴油机相继增压高温阀 机械老化分析

Mechanical Aging Analysis For High Temperature Valves of Sequential  
Turbocharging of Marine Diesel Engines

**中国船舶集团有限公司第七一一研究所**  
Shanghai Marine Diesel Engine Research Institute

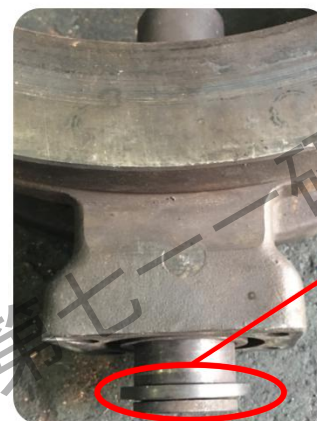
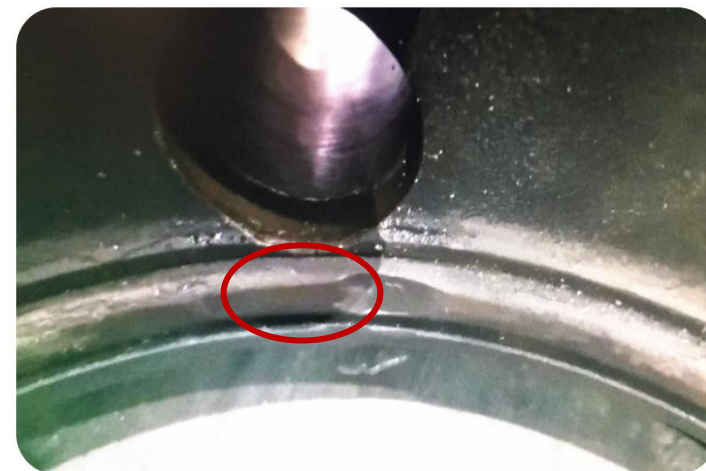
➤ 卡环：高温阀门阀杆轴向定位作用，失效后阀杆上下窜动，导致密封圈失效；

Half clasp: high temperature valve axial position orientation, valve axial fluctuate up and down after half clasp failure, finally, result the seal ring failure.
